# **STUDDED TIRE PAVEMENT WEAR REDUCTION & REPAIR**

## **PHASE 1**

Y-1439

DECEMBER 1972

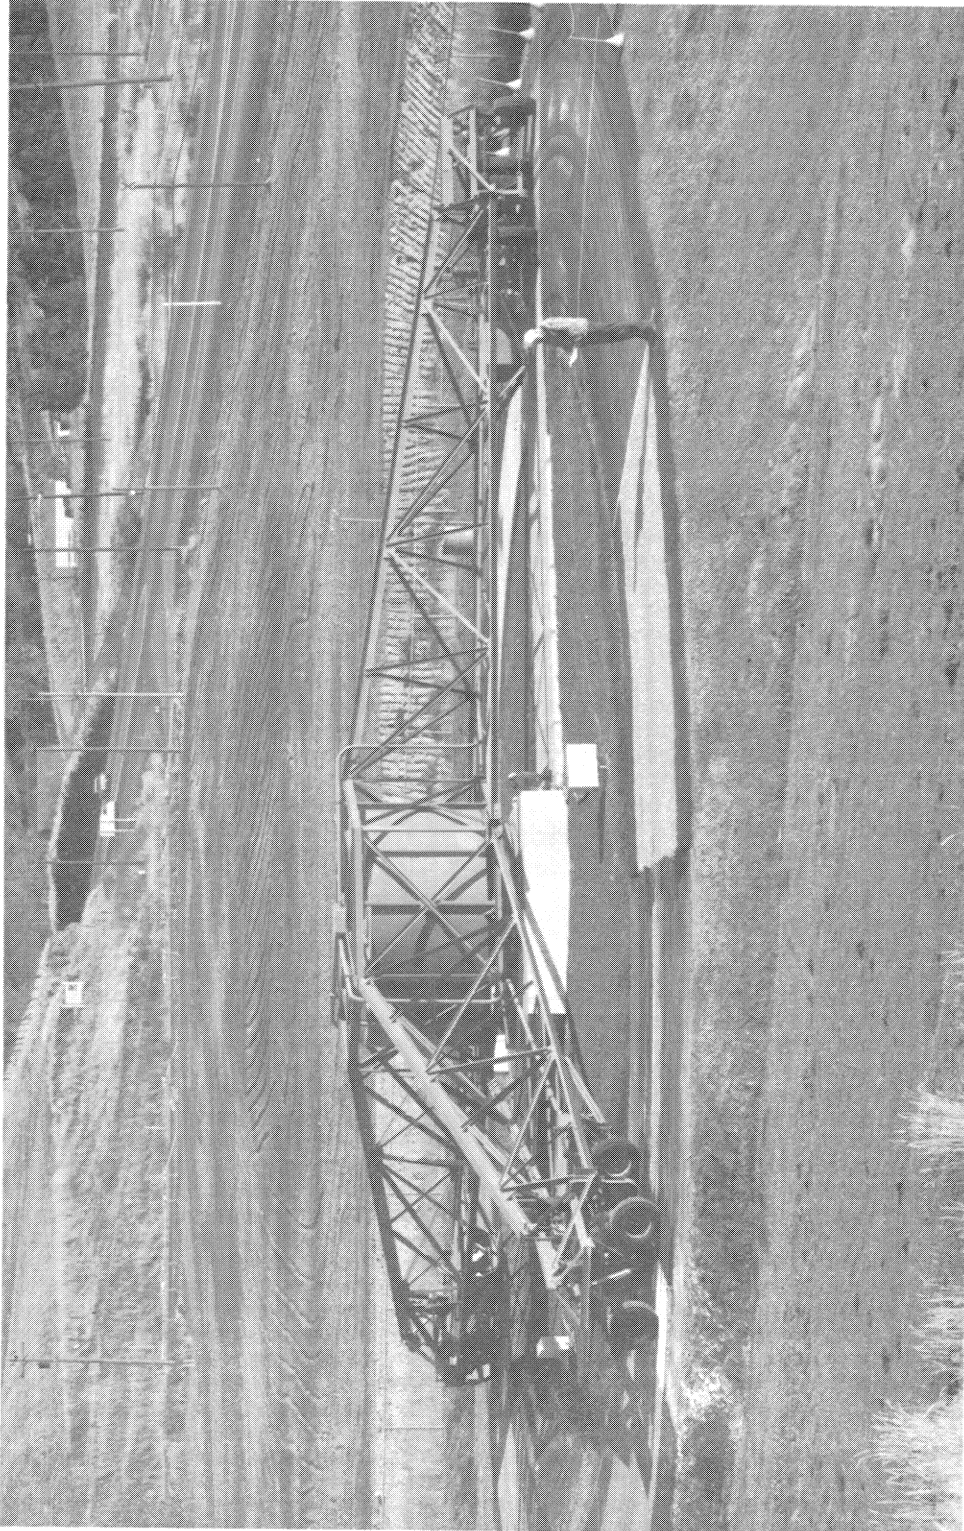
Figure 1: An overall view of the G. A. Riedesel Pavement Testing Facility with modifications and the track. The track shown here is Ring No. 6.

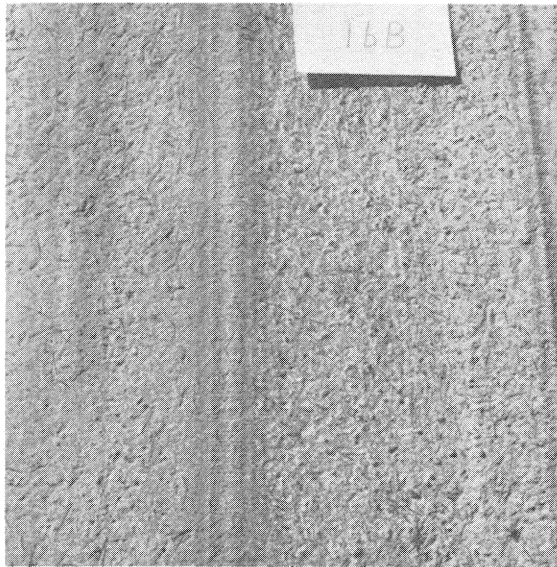
FIGURE 57

(a) Wheel path #2 and 3 caused by stud types #1 and 2 respectively.

(b) Close up of wheel path #2 and 3 caused by stud type #1 and #2, respectively.

(c) Wheel path #4 and 3 caused by stud types #3 and #2 respectively.
